Cross-section Paint Microscopy Report

Room 100 Interior Paints Historic Sandusky, Lynchburg, Virginia

Date: March 11, 2015

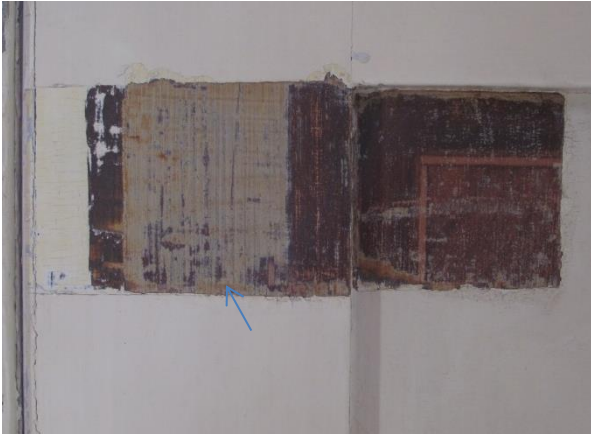
100-5SB

- 100-5SB. South wall door, on outer edge of Chris Mills exposure, that seems to be oak graining.
- 100-9SB. Top edge of riser below landing.
- 100-14SB. North wall window architrave, left side.
- 100-15SB. North-facing fascia below second-floor landing, left side of cut-out section

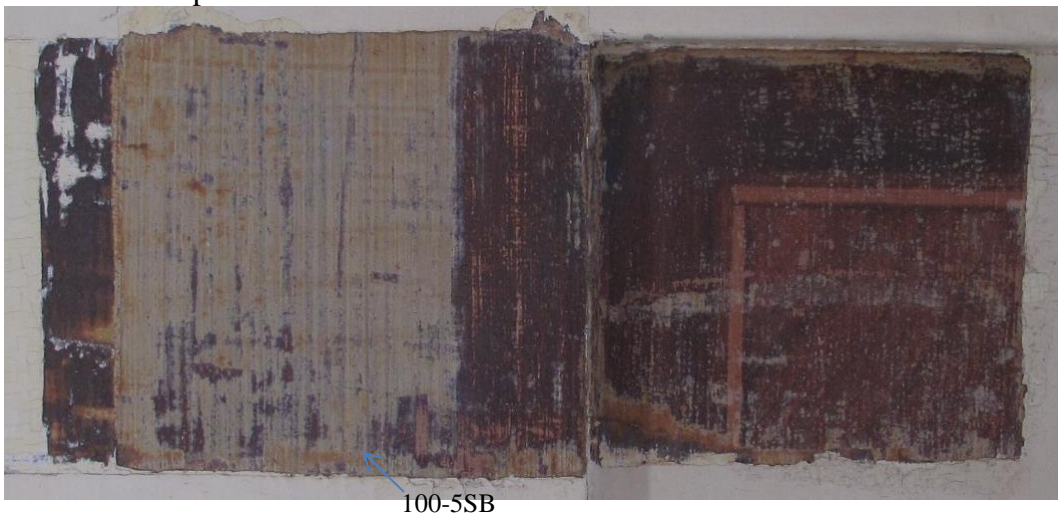
Chris Mills Exposure on Main Door

When Chris Mills created his exposures on the doors in the Entry he noted that all three doors in the space seemed to have had the same paint treatments.⁴ He identified the first graining generation as mahogany with faux-painted inlay (at right in the photograph below). He interpreted the next generation as mahogany graining with a gray sealer, reddish-brown base coat and dark brown graining. However, he was concerned that this second generation of graining might not have been accurately revealed and asked that it be rechecked with cross-section microscopy analysis.

This exposure was sampled at the lower edge on the left side where there is a brownish glaze on top of the grayish layer to determine whether this might actually be oak graining that could not be consistently revealed (sample 100-5SB). This door was also sampled during an earlier phase of research (sample 100-10) and the evidence in that cross-section suggested that there were actually three generations of graining on the door, consisting of oak graining sandwiched between two generations of mahogany graining.

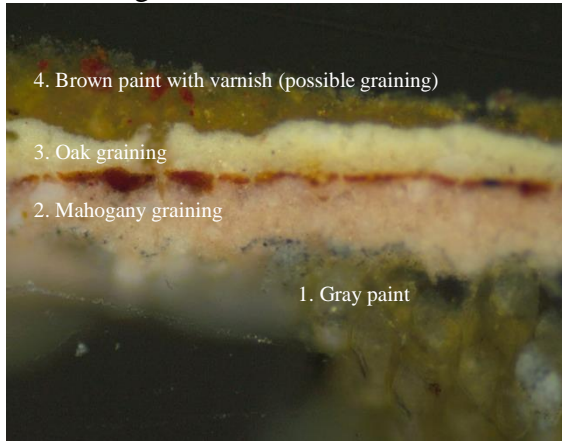
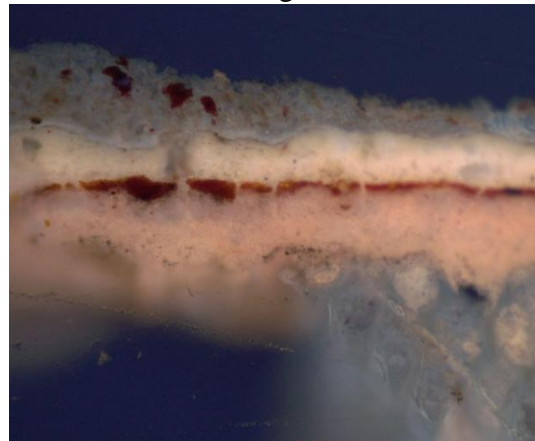
Sample 100-5SB. South wall door, on outer edge of Chris Mills exposure, that seems to be oak graining.

The cross-section evidence in 100-5SB and 100-10 confirm that this door was first painted gray, like the rest of the woodwork. This was followed by the mahogany graining that is now cleanly exposed on the Entry doors. The third generation is oak graining with a very thin brown glaze layer on a cream-colored base coat and a thin plant resin varnish. Generation 4 may also represent mahogany graining with a pinkish-brown base coat. Generation 5 is a brown paint with a varnish. The most recent paints are off-white and gray. If generation 3 is the target period for interpretation of the parlor and entry, then it seems that the parlor door was oak-grained in the same manner on both sides, and the main door may have been oak-grained on both sides as well. Fluorochrome binder analysis confirms that all the paints in this coating sequence are traditional oil-bound paints.

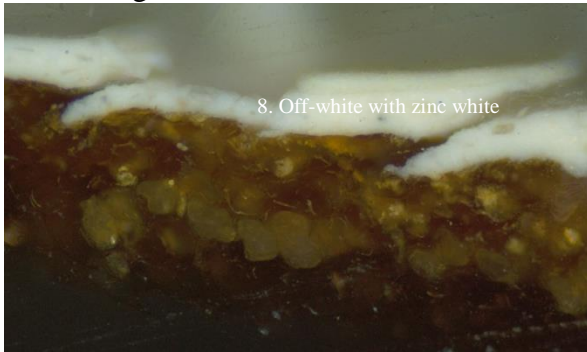
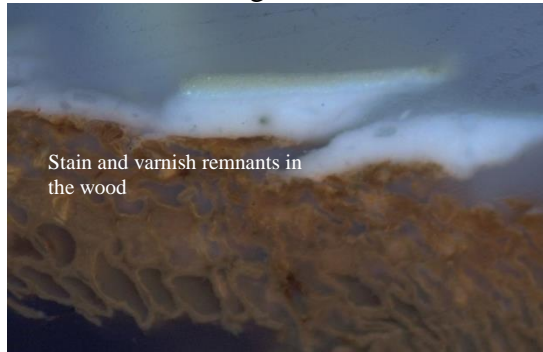
Sample 100-9SB. Top edge of riser below landing.

No grain-painting was found on any of the staircase elements. But the limited evidence in sample 100-9SB from the stair riser suggests that the wood was originally stained red-brown and varnished. Sadly, the risers seem to have been mostly stripped of their paint evidence before toff-white paint was applied in generation 8. Examination of the uncast portions of samples from the handrail and treads indicates that these elements were also stained and varnished, although the earliest varnish coatings are compromised by later stripping and revarnishing efforts.

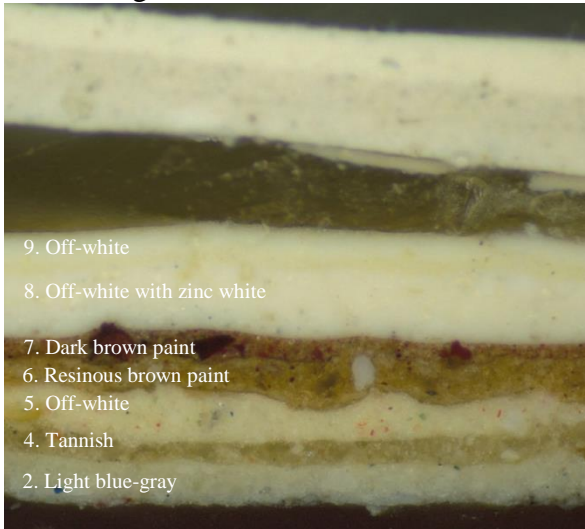
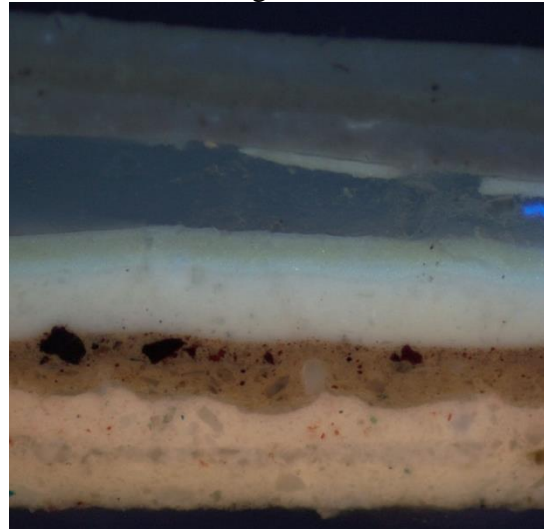
Sample 100-14SB. North wall window architrave, left side.

The staircase and landing elements were sampled to determine how they were painted compared to the first-floor woodwork (see sample 100-3SB from the surbase and sample 100-12 from the tripartite doorway for reference). Comparisons of three cross-sections and ten uncast samples suggests that the window sash and architrave (100-14SB), and the balusters, stringer and newel post were all initially painted gray, and the second-generation paint on all these elements was light blue gray. The third generation is missing from some of the samples, perhaps due to surface preparation during later repainting efforts, but it appears to have been the same cream color found during the earlier phases of analysis.⁵ This was identified as the ca. 1849 paint on the woodwork.

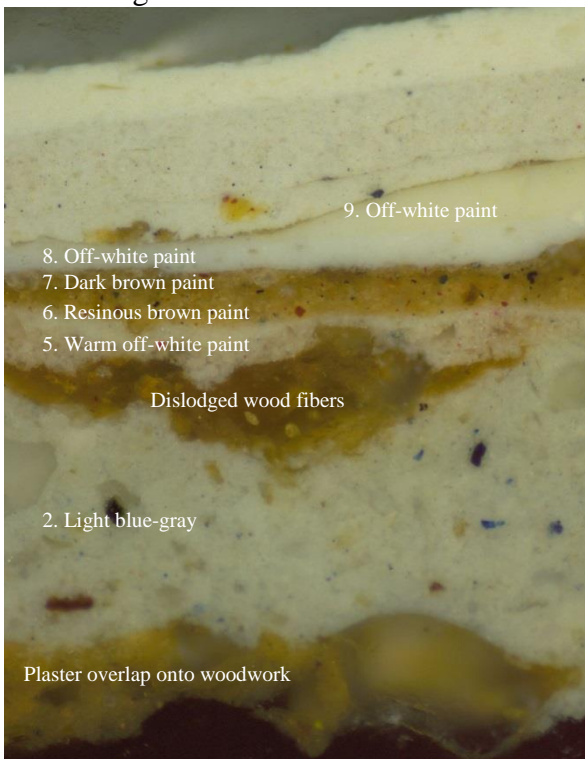
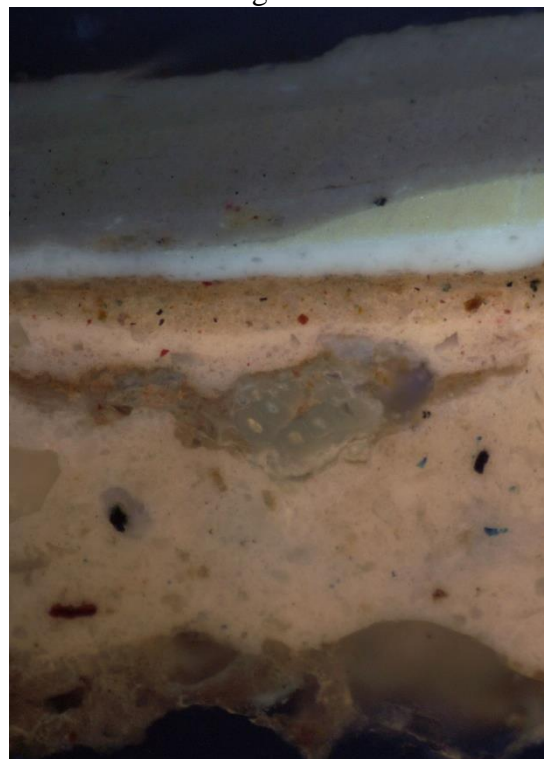
Sample 100-15SB. North-facing fascia below second-floor landing, left side of cut-out section.

During the investigation on-site it appeared that the fascia board below the second-floor landing might have been grain-painted early on. But in cross-section 100-15SB it is apparent that this element was always painted to match the rest of the woodwork, beginning with the original gray paint. This sample was taken from the east side of this board, where it abuts the wall. There is a slight overlap of sandy plaster from the wall in the cross-section, but no early wall paints were discovered in this cross-section.

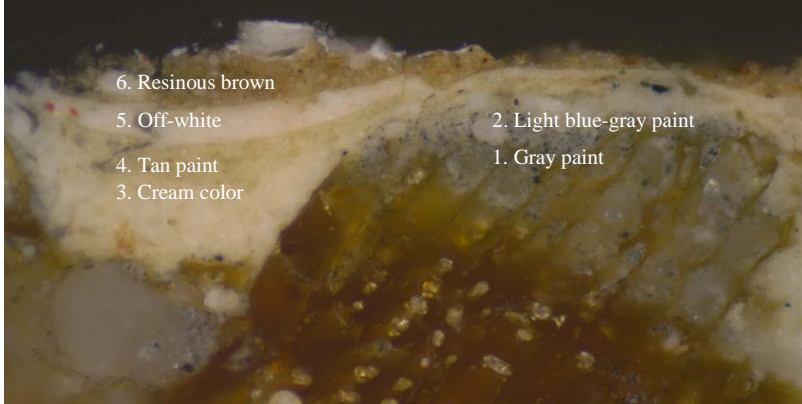
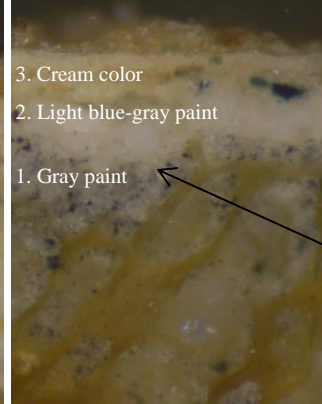
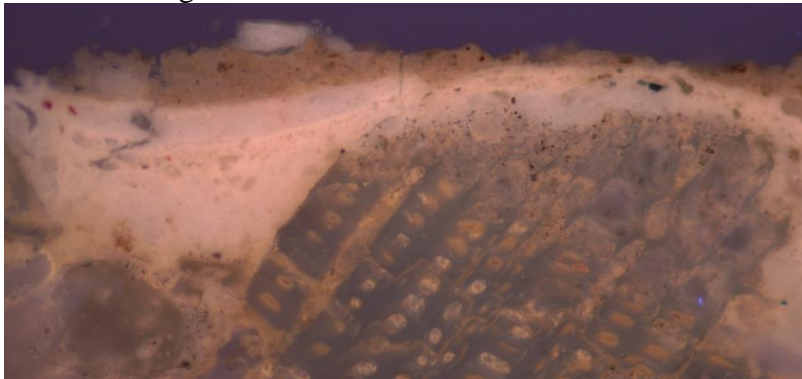
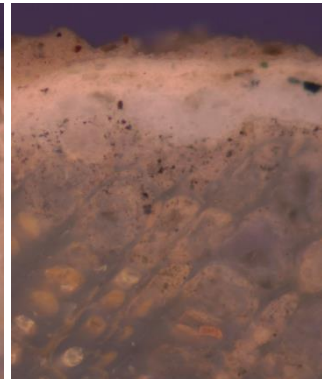
Sample 100-12. South wall, part of tripartite doorway with sidelight (similar to 11 and 18).

Gray paint is eroded and cracked
