Cross-section Paint Microscopy Report

Room 100 Interior Paints Historic Sandusky, Lynchburg, Virginia

Date: March 11, 2015

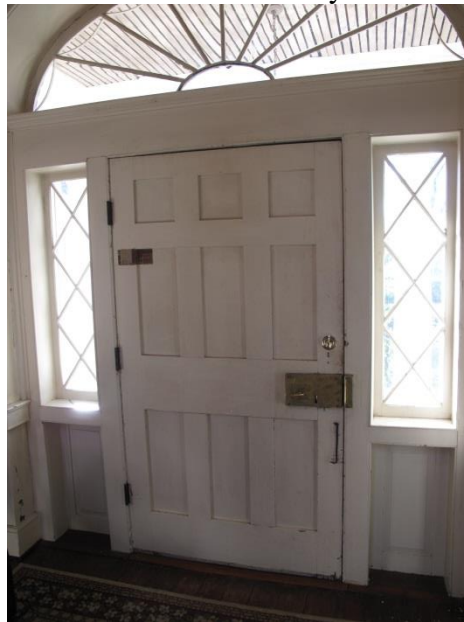
Room 100 Entry

The goal of this project is to use cross-section microscopy analysis to identify the sequence of coatings on the overpaint removal exposure on interior of the Entry door of ca. 1810-12 Historic Sandusky. The exposure was created by Chris Mills in July 2014, and the primary question was whether this door might have been oak grained to match the Parlor door during the 1849 interpretation period.

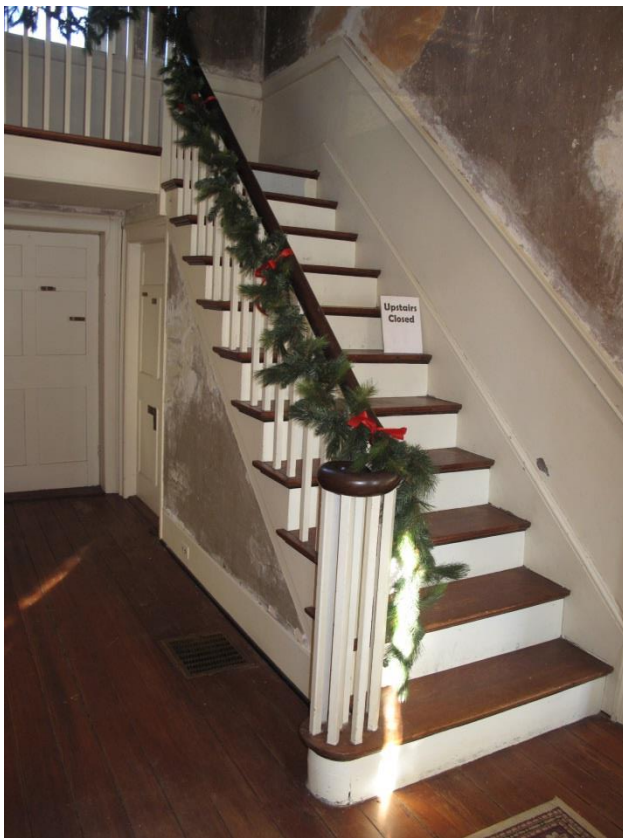
Room 100 Staircase and Rear Door

No grain-painting was found on any of the staircase elements. But the limited evidence in sample 100-9SB from the stair riser suggests that the wood was originally stained red-brown and varnished. Sadly, the risers seem to have been mostly stripped of their paint evidence before toff-white paint was applied in generation 8. Examination of the uncast portions of samples from the handrail and treads indicates that these elements were also stained and varnished, although the earliest varnish coatings are compromised by later stripping and revarnishing efforts.
